WELDING INSPECTION REPORT

OSM Arrival Time: 700 **Project Name:** SAS Superstructure **OSM Departure Time:** 1500 **Prime Contractor:** American Bridge/Fluor Enterprises, a JV

34-0006 **Bridge No: Component:** Orthotropic Box Girder (OBG)

OBG Assembly Bay- 14.

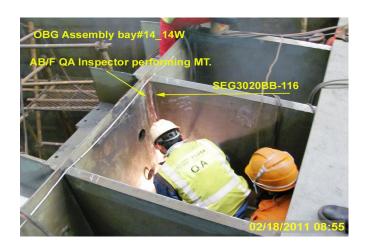
American Bridge /Fluor (AB/F) QA Inspector was performing Magnetic Particle Testing (MT) on weld back gouged area for the weld joint identified as SEG3020BB-116.Refer the attached photos for reference.
